LCU500

ENVIRONMENTAL TEST REPORT

75-99-5371

JUNE 2003

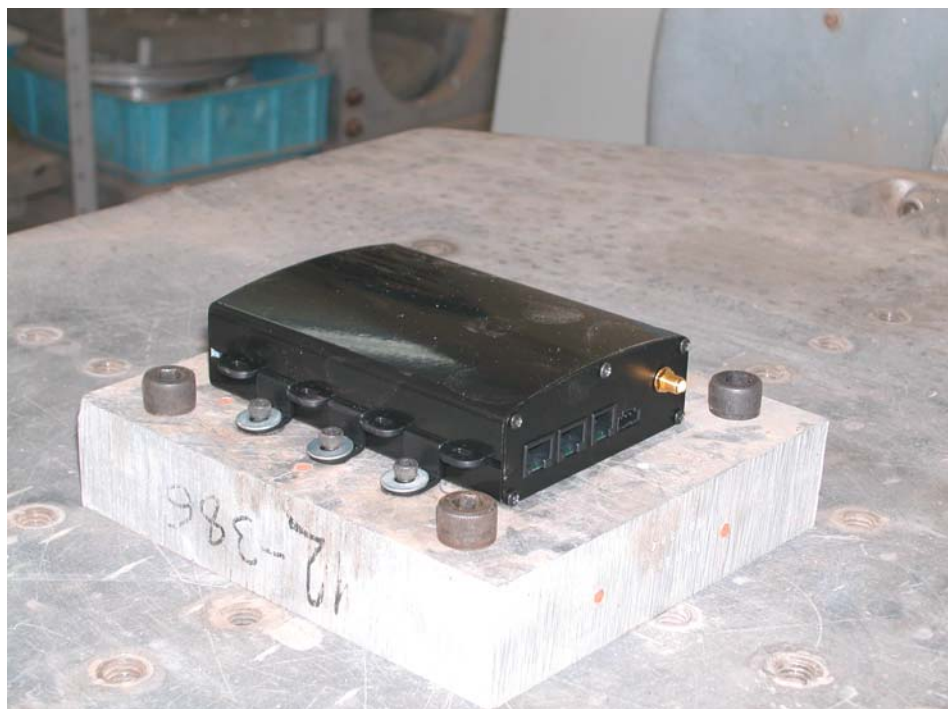
Photo No. 1: Vibration and Shock testing, Lateral axis

No visible damage was observed during the test and at its completion.

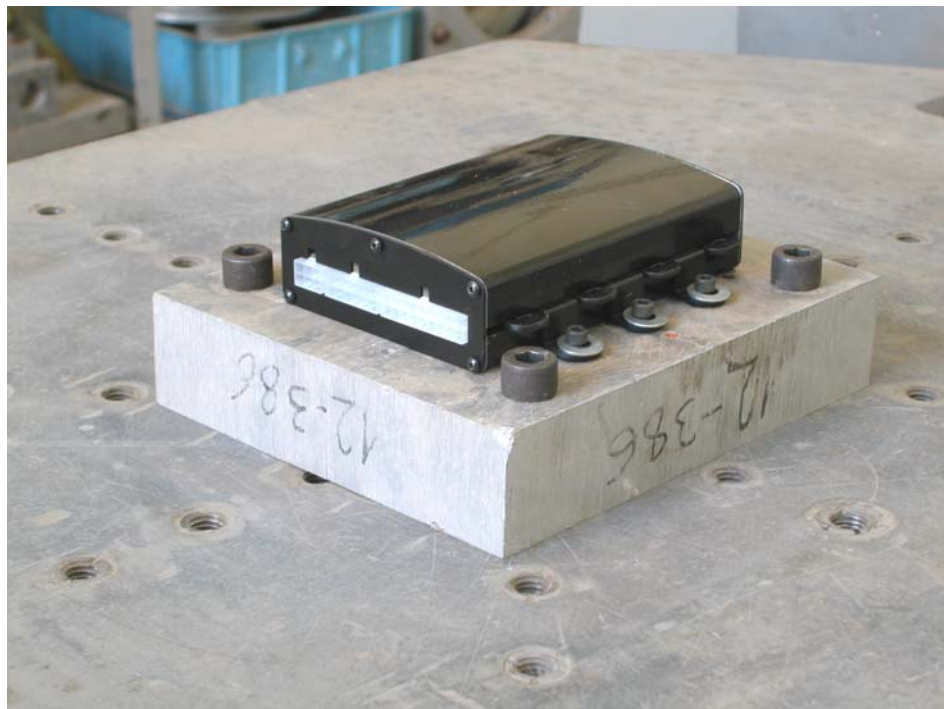
Photo No. 2: Vibration and Shock testing, Longitudinal axis

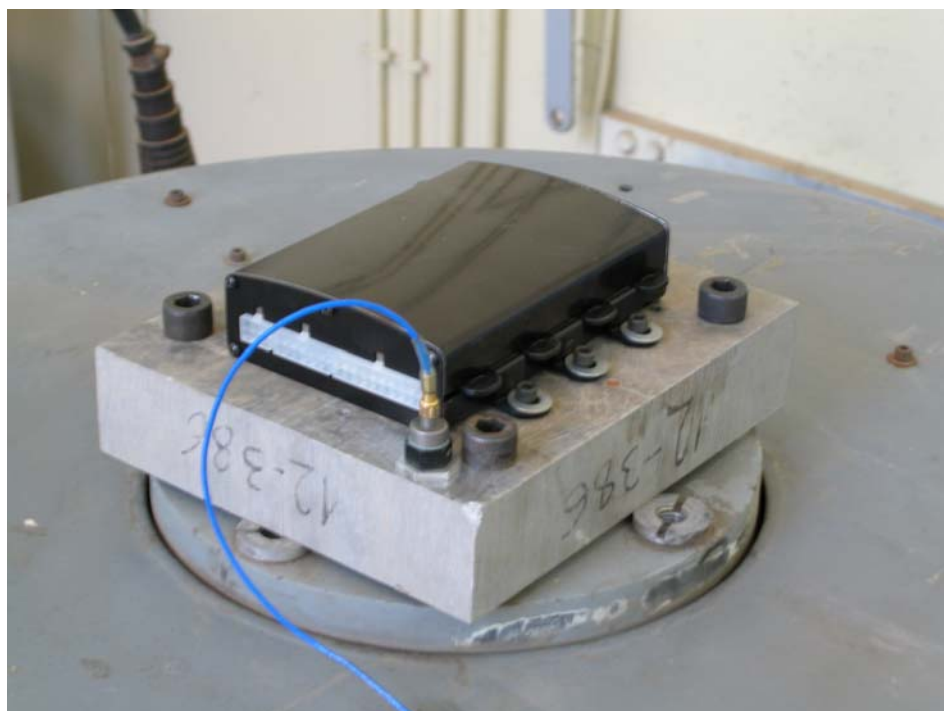
Photo No. 3: Vibration and shock testing, Vertical axis
